HAZARDOUS MATERIALS SPECIAL INVESTIGATION REPORT

**HAZARDOUS MATERIALS RELEASE
MISSOURI PACIFIC RAILROAD COMPANY'S
NORTH LITTLE ROCK, ARKANSAS
RAILROAD YARD
DECEMBER 31, 1984**

NTSB/SIR-85/03

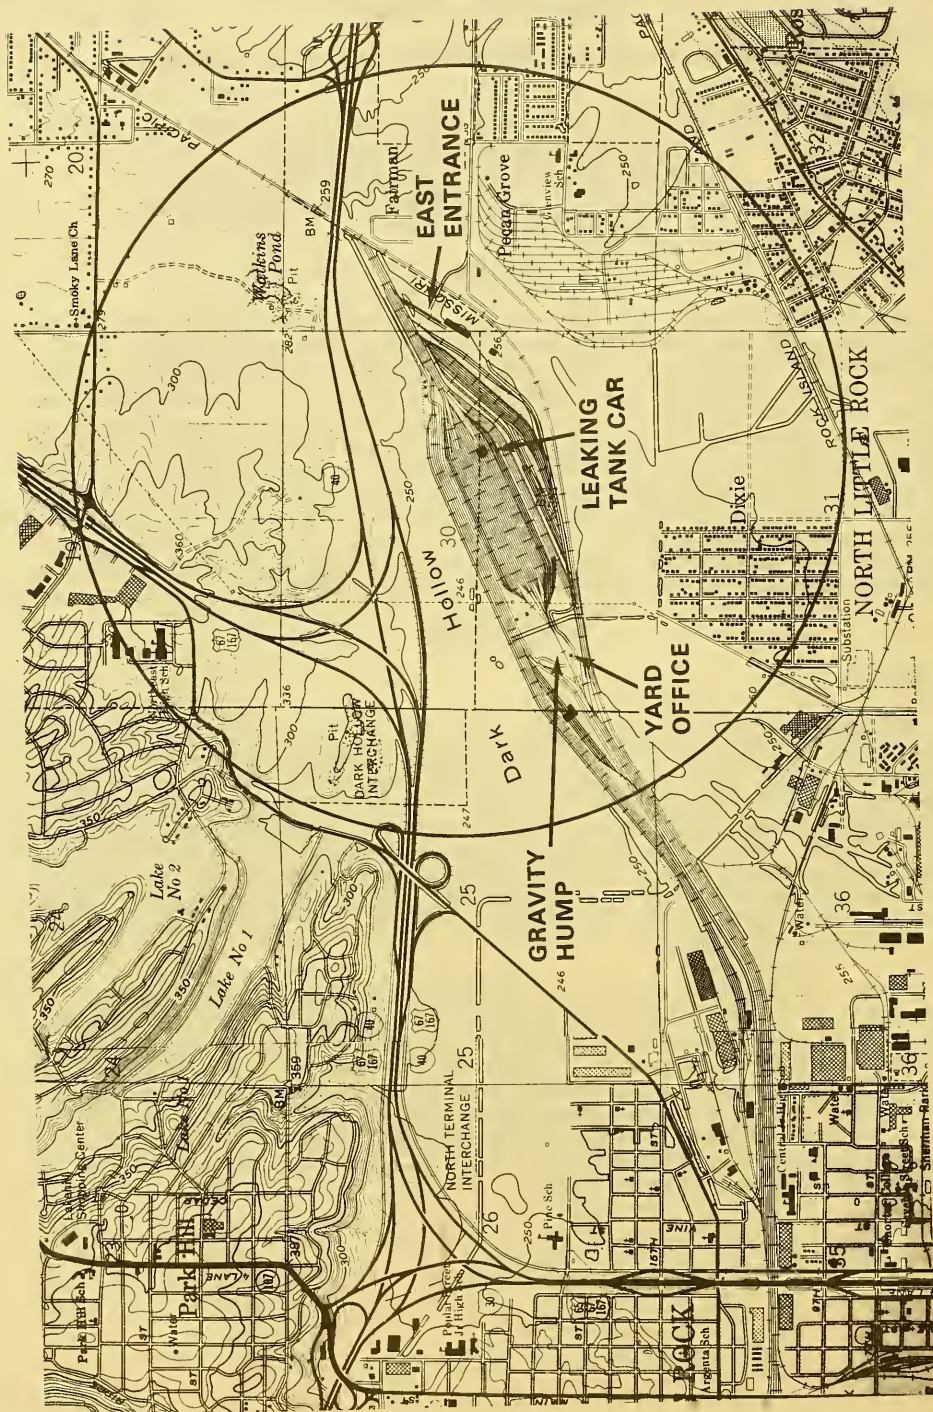
Figure 1.--Area evacuated around RAIX 7033.

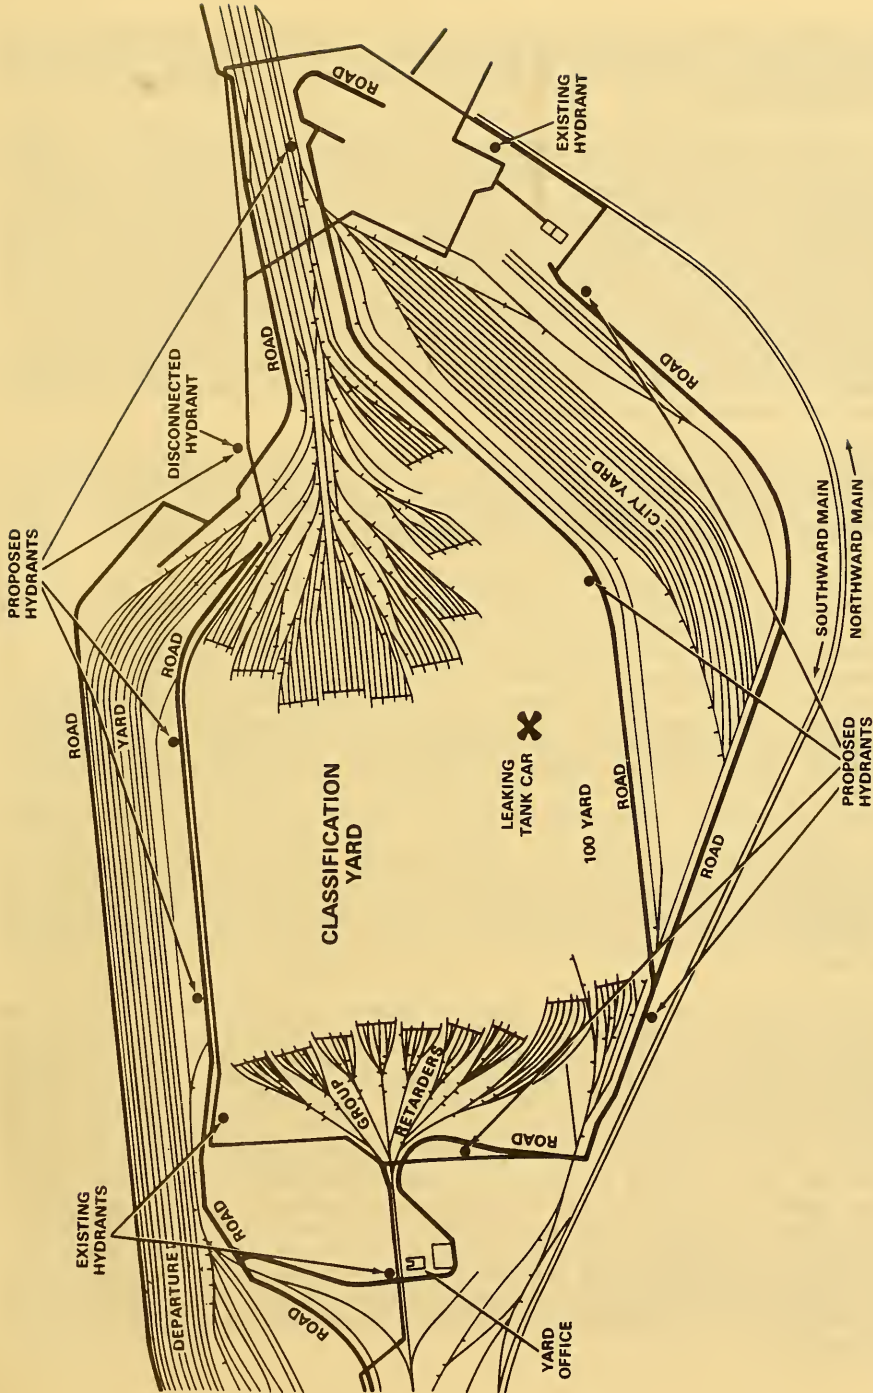
Fire department personnel tested three fire hydrants in the yard. The first hydrant tested had no water (it had been disconnected earlier from the water main because of construction). The second hydrant had less than 1 pound of water flow pressure, and the third hydrant, which was an estimated 1,875 feet from the leaking ethylene oxide tank car, had less than 10 pounds of water flow pressure. The fire chief stated that the low water pressure was insufficient to supply water through firehoses. To lay firehose to the leaking tank car from any of the fire hydrants, it would have been necessary for the firehose to cross many railroad tracks, some of which were occupied by freight cars. The nearest road was about 437 feet from the leaking tank car, and 21 railroad tracks were between the road and the leaking tank car, with most of the tracks occupied with freight cars. (See figure 2.)

Figure 2.—Sketch of railroad yard showing tracks, fire water system, and access roads in relation to the leaking tank car.

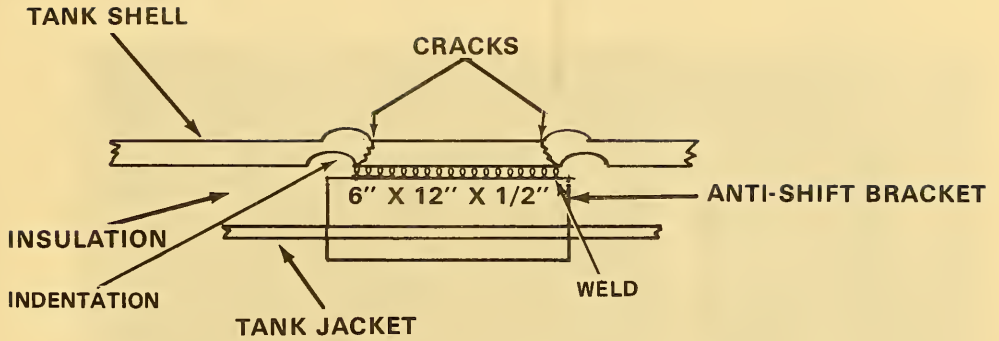
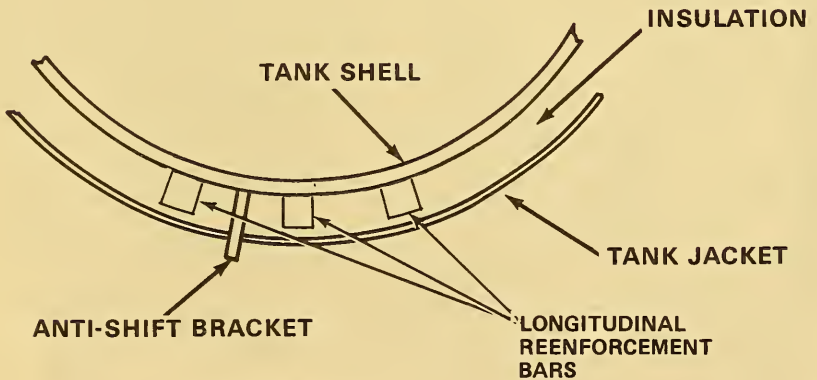
On January 2, the tank car was transported by rail to Carbide's plant at Taft, where it was flushed with water and drained. An internal visual inspection of the car revealed two through-wall cracks near the center of the bottom of the tank. The internal crack locations corresponded approximately to the extremities of the 9-inch-long welds attaching the anti-shift bracket to the tank shell. The cracks ranged from 2 1/2 to 3 3/4 inches long and were half-moon shaped.

Metallurgists from Carbide and the Safety Board removed a section of the tank shell for metallurgical examination. The section included two through-shell cracks, two indentations, a section of the tank shell bottom plate longitudinal reinforcing bar, the anti-shift bracket, and part of the jacket that was attached to the anti-shift bracket. (See figures 3 and 4.) The metallurgical examination was conducted by a metallurgical consultant in Houston, Texas, under the supervision of the Safety Board's metallurgist.

Figure 3.--Sketch of tank car sample area.

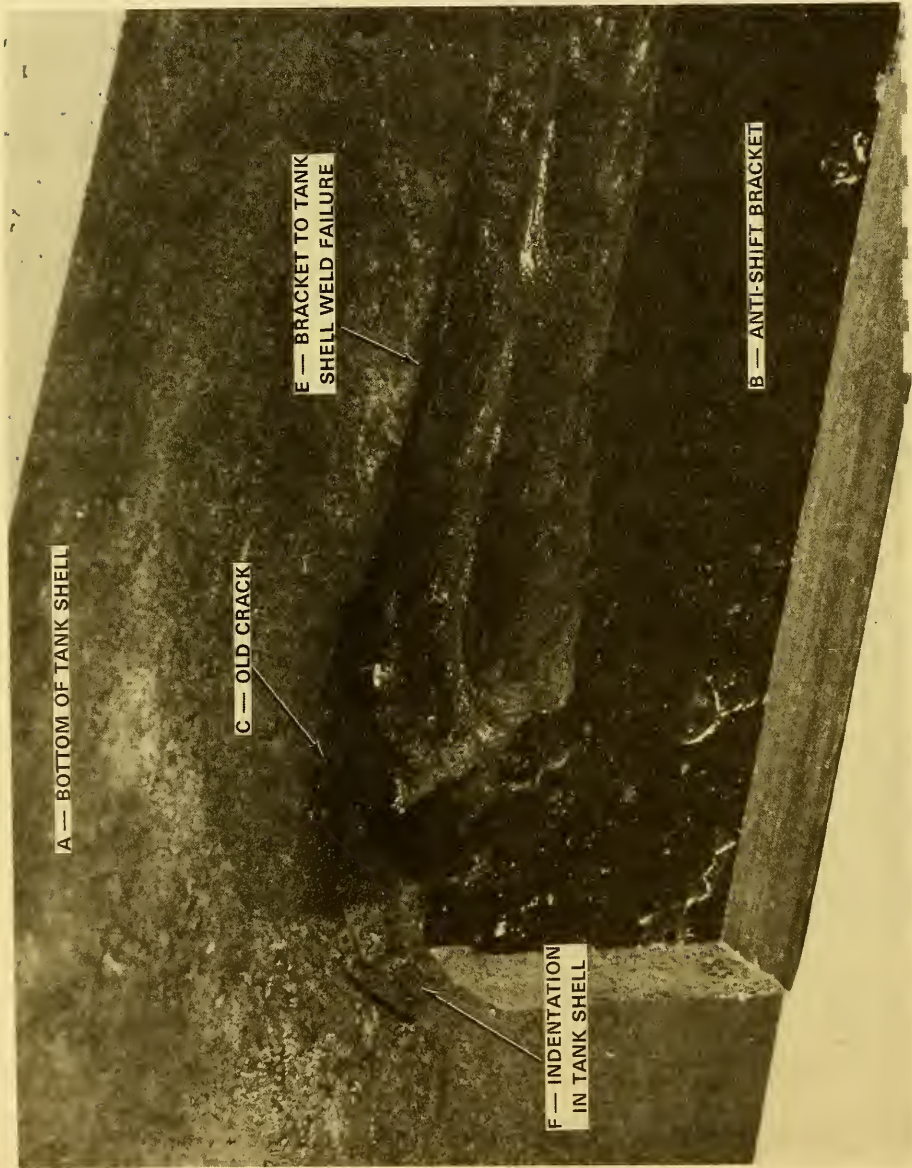
The car then was moved to a railcar repair shop at Texarkana, Arkansas, where it was inspected on January 17, 1985. The tank insulation protection jacket was found to be capable of moving longitudinally along the tank. Two indented areas containing sharp impressions of the ends of the anti-shift bracket were found in the tank shell immediately beyond the extremities of the cracks. A slight out-of-round section was found in the tank near the upper right side of the B-end body bolster attachment which appeared to have been related to previous damage.

Figure 4.—Photograph of anti-shift bracket.

- (1) The progression of the cracks at the toe of the fillet weld to shell indicates that the cause is plastic-hinge (repeated) tensile stress. The progression is in an inward shell thickness direction, that is not preferential to Heat Affected Zone (HAZ), except at the geometric induced starting point. The opening up of inclusion sites on both sides of the cracks clearly indicates tensile crack-opening stress due to hinge point rotation of repeated type.

- (4) The penetration of the shell at the two ends of the fillet welds to shell connection is due to a progression of low cycle fatigue crack from A and B ends of the vertical bracket. The sites that developed the first cracking were the sites of first complete penetration. The low cycle fatigue cracking mechanism is consistent with the type of final penetration of shell.

1. Ethylene oxide leaked from the tank car as a result of two through-shell cracks near the center of the bottom of the tank at each extremity of the welds on the anti-shift bracket.

2. The tank car jacket anti-shift bracket was welded directly to the bottom of the tank shell in violation of 49 CFR 179.200-19(b).
3. As the tank car jacket moved relative to the tank during normal operations, cyclic forces were transmitted through the anti-shift bracket to the tank shell.
